PHASE I INSPECTION REPORT
NATIONAL DAM INSPECTION PROGRAM

BRIER CREST WOODS DAM

NDI ID No. PA-00879
DER ID No. 45-245

FEBRUARY 1980

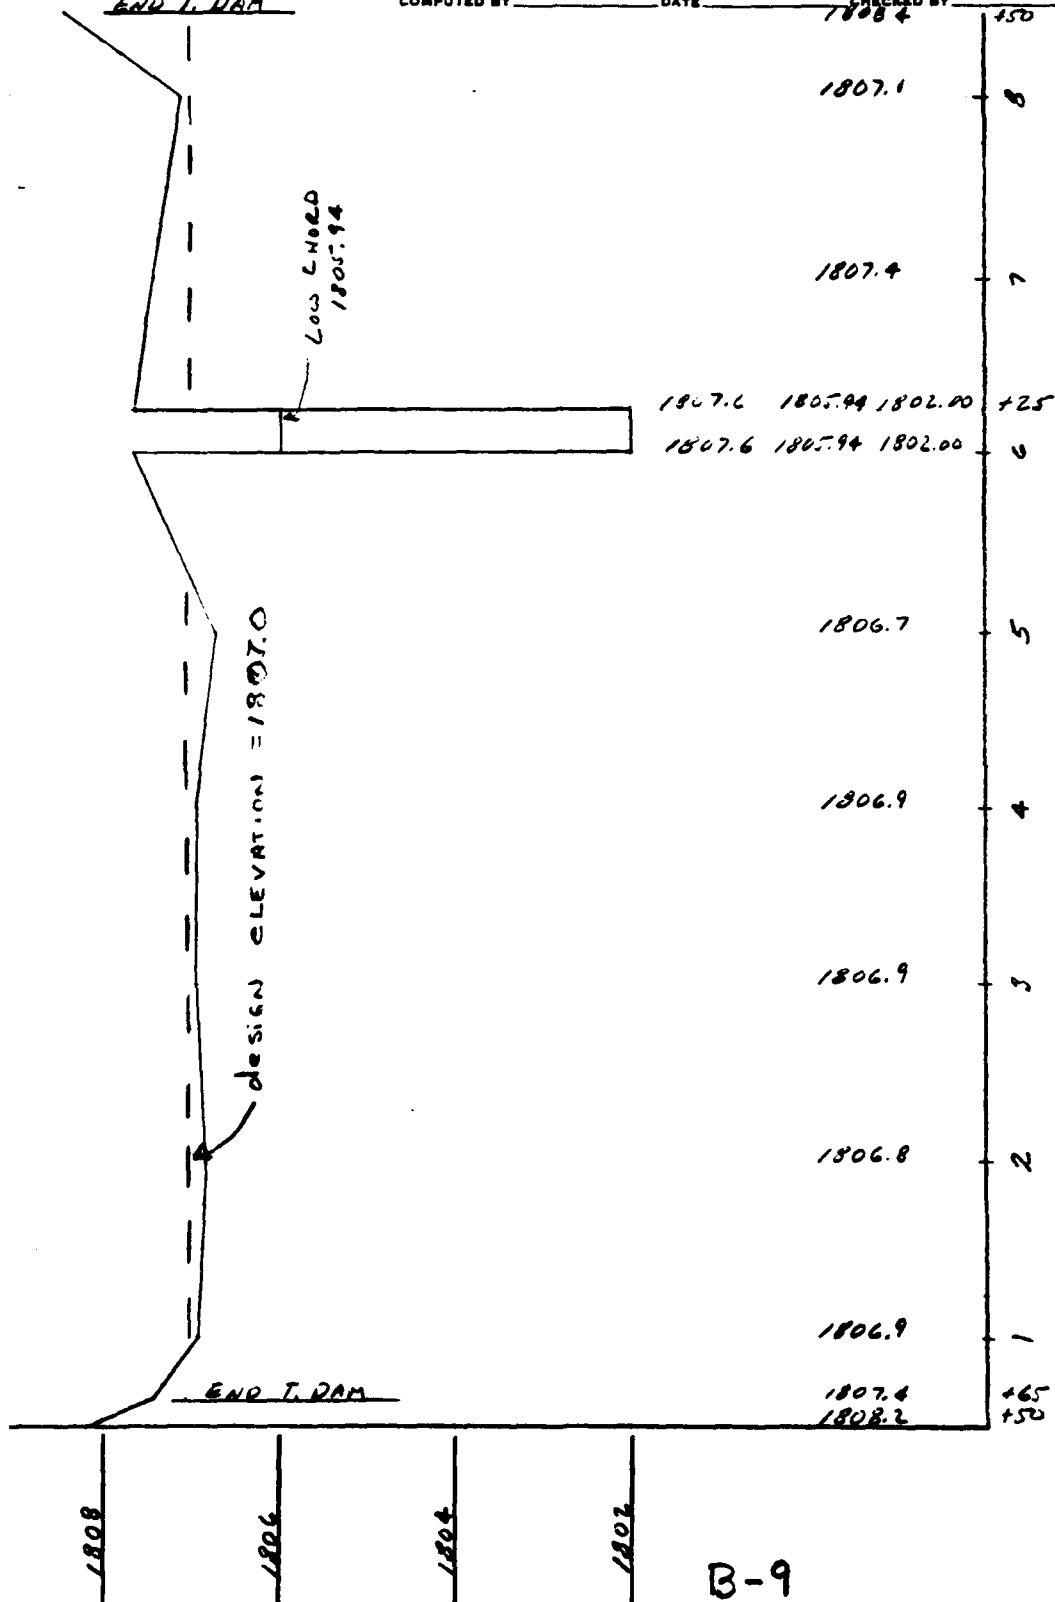
B-9

BEIRCK CREST WOODS DAM
Profile - Top of DAM
